IKAR/CISA 2004
Zakopane - Poland
Kommission für Luftrettung
Commission pour le Sauvetage Aérien
Commission for Air Rescue

Prepared By:

ACCIDENTS/INCIDENTS FROM MEMBER COUNTRIES:

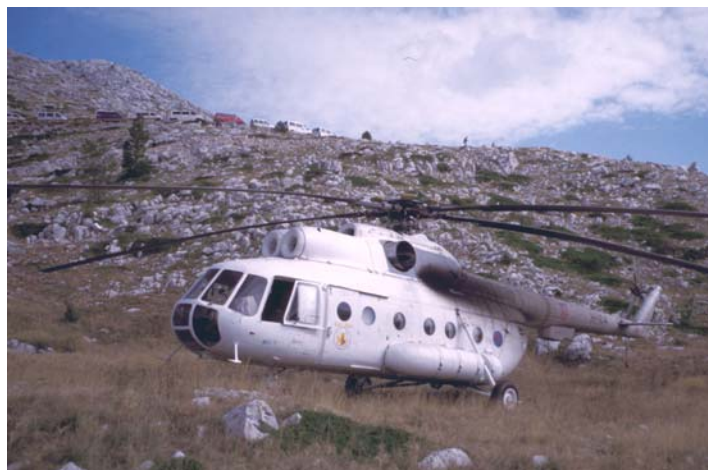
MI8, crash

During a night flight for a medevac operation, the helicopter is returning to base after dropping off the patient at a hospital. During taxi on the apron, the aircraft begins to bounce from left to right. The pilot pulls collective without applying pedal. This aircraft is reportedly unforgiving in this situation. The helicopter lifts about 6 meters off the ground, begins to spin and then crashes. The helicopter is carrying two tons of fuel. Both pilots and one passenger are badly injured.

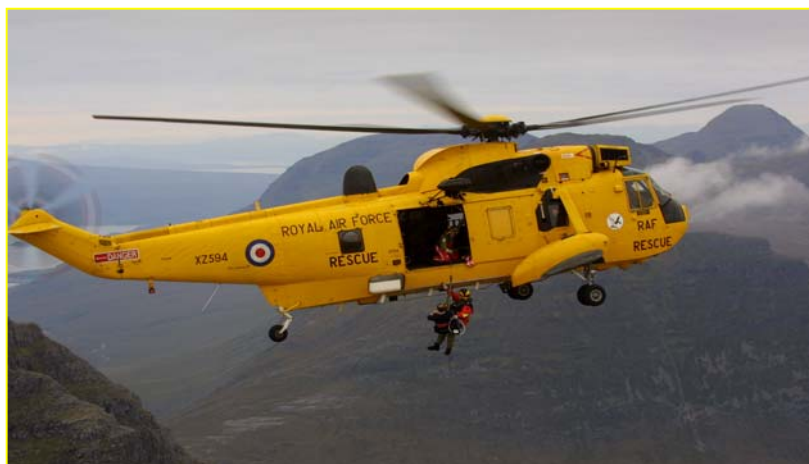
Sea King, rotor strike, Class D release

During a mountain rescue operation for a fallen climber in the Lake District, the aircraft main rotor strikes the cliff during the hoisting operation. The pilot calls for hoist cable release but the co-pilot hits the wrong switch on the overhead panel. The rescuer realizes that the aircraft is in difficulty and intentionally releases from the strop that he is riding in. He falls about 10 meters and is slightly injured. The Sea King is able to land safely after losing approximately 2.5 meters from the main rotor.

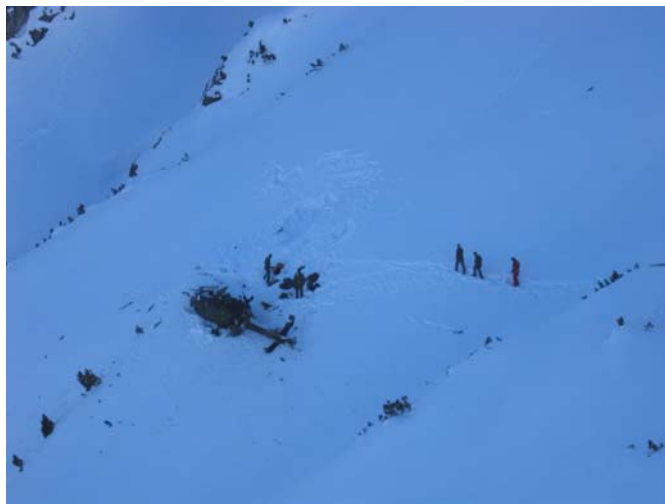
BO105, crash (2003)

While attempting a landing on a glacier in the Garmisch region, the military helicopter crashes. The pilot loses reference on final in self-imposed "whiteout" and attempts to land without reference on sloping ground. The main rotor strikes the ground and the helicopter rolls. The helicopter is destroyed. There are minor injuries.

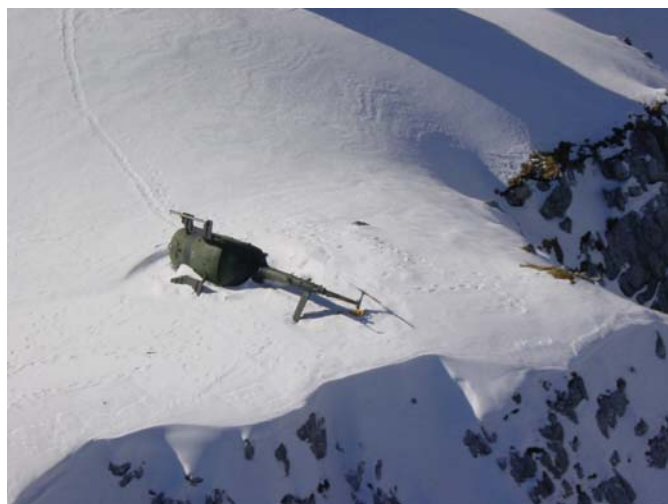
BO105, crash (2004)

While attempting a landing on a snow covered high altitude shoulder in the Allgau region, the helicopter crashes. The landing spot is not flat and there is little reference. The helicopter rolls and slides to the edge of a very large cliff. There are minor injuries.

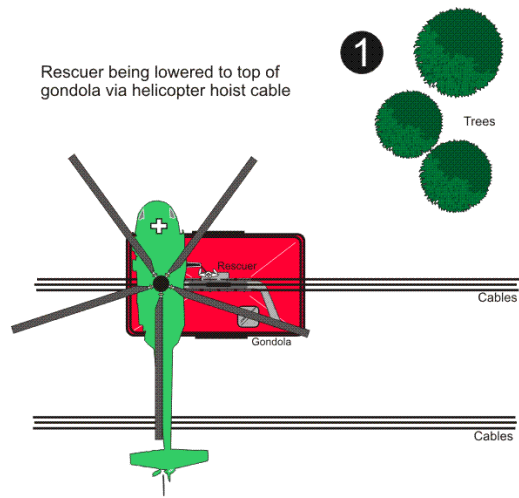
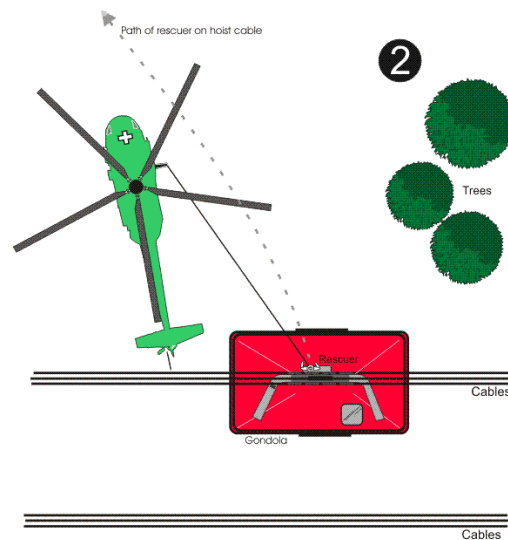
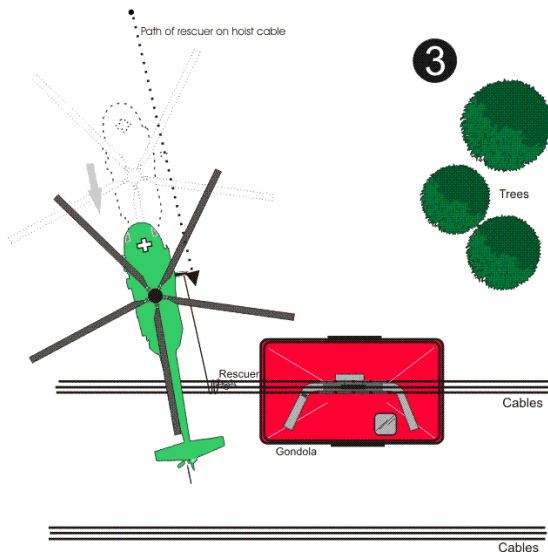
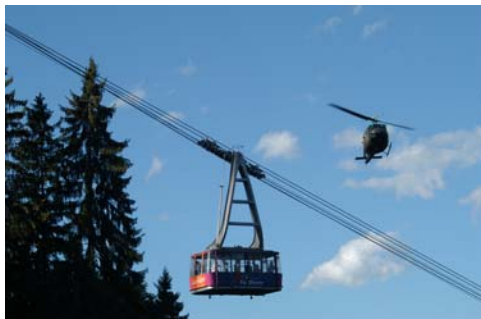
BH205, class D release

This accident occurred during a training mission for a cable car evacuation at the Fellhorn Ski Area in the Allgau region. A rescuer is hoisted down towards the roof of the cable car. In order to keep the aircraft into wind, the pilot keeps the helicopter and rescuer upwind of the cable car cable. There is 30 meters of hoist cable out. Since he cannot see the cable car, he uses trees in the distance for reference. There is no communication between the rescuer and the aircraft. At one point, a gust of wind makes him apply forward cyclic and the rescuer swings violently forward. When trying to recover, the rescuer swings back and wraps around the sloping cable car cable twice. He is injured but is within reach of the cable car cable. He manages to climb onto it before the hoist operator severs the hoist cable. He is then able to climb down to the cable car safely with the assistance of other rescuers in the cable car.

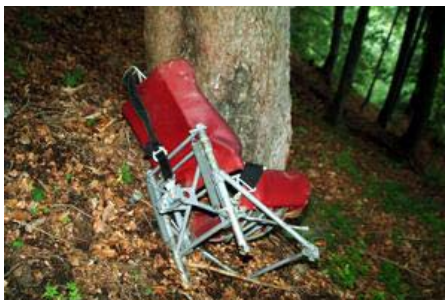
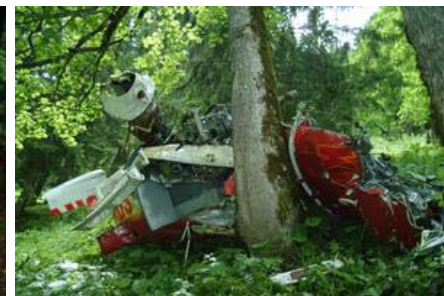
BH205, crash

While carrying a one-ton load on a long-line, during a commercial operation, the pilot experienced difficulty during a steep climb. He dropped the load and turned around but crashed into the forest. The pilot was killed.

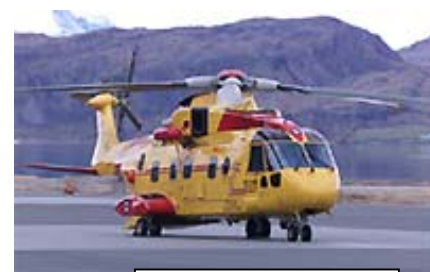
EH101, hoist problems

An incident occurred during a nighttime rescue in the North Atlantic for the crew of a capsized fishing vessel. The crew of six was floating in a life raft. Due to the very heavy seas with 15 metre waves, the lowering of the rescuer on the hoist was problematic. The rescuer lost his swim gear in the water and the hoist operator was having difficulty keeping him near the surface. The rescuer was brought back on board and it appears that with the constant up and down motion on the hoist, it overheated and was no longer operational.

The operation was transferred to the second hoist (this aircraft is equipped with two hoists) and a rescuer was lowered to the water. He recovered one of the fishermen. He returned to the water and for some reason, at some point, the hoist cable was jettisoned. The helicopter no longer had any hoist capability. The rescuer was recovered with a stretcher on a rope tied to the hoist arm and was subsequently long-lined to the top of the cliff above the shore. At that point, the rest of the fishing vessel crew had drifted onto the rocky shore. The helicopter rescue crew along with the help of ground rescue crews recovered two more fishermen with rope work. One other person managed to scramble to the top unaided. Two fishermen died in the incident.

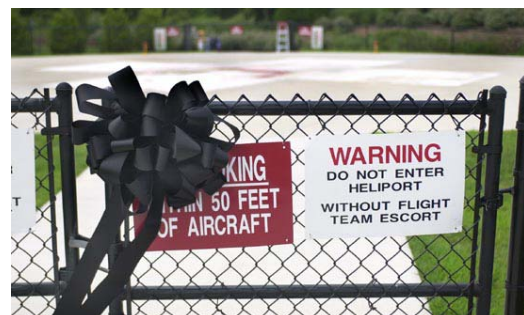
NEWBERRY, SOUTH CAROLINA- AIR AMBULANCE CRASH

On July 13, 2004 Spartanburg *Regional One* (Spartanburg, SC) Air Ambulance Bell 407 helicopter crashed during a patient transport. Pilot, flight nurse, flight paramedic, and patient were killed. The aircraft crashed at 5:36 a.m., seconds after it took off from an accident near an Interstate 26 rest area. This aircraft had been operated by the Med-Trans Corporation for Spartanburg Regional Healthcare since May 2003. There were two other fatal USA air ambulance accidents during 2004 (as of October 2004), but the circumstances behind this tragedy are worth reviewing. Spartanburg Regional One was contacted after three other air ambulance units had declined the mission based on weather conditions.

- Spartanburg Regional Healthcare System is contacted, which agrees to send a helicopter.....
- Before lifting off from Spartanburg, the pilot checked weather radar. Aviation Weather Center in Kansas City, Mo., issued a visibility advisory two hours before the crash. This was for a four-state region of the Southeast, including where the helicopter went down.

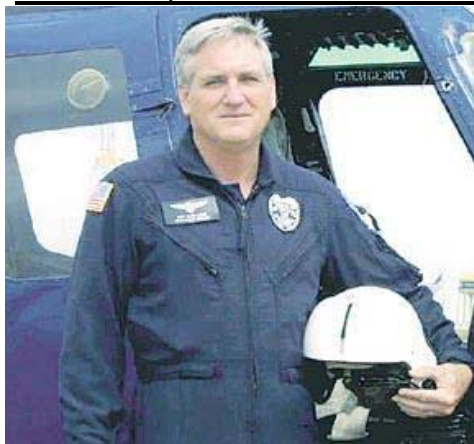
BEAUMONT, TEXAS- SHERIFF'S DEPARTMENT HELICOPTER CRASH

On September 15, 2004 a Bell OH-58C (military BH-206) crashed during a search & rescue mission. 54 year-old Jefferson County Sheriff's Sergeant, Mike Lane was killed when a helicopter owned by the Sheriff's Department crashed into Sabine Lake. Sabine Lake is connected to the Gulf of Mexico. The pilot and Mike Lane, a pilot-rated sheriff's deputy spotter, were looking for a victim of a reported boat fire. After locating the fire, which turned out to be burning garbage on shore, they continued to search the area for any boat fire "survivors". The aircraft descended from an altitude of 500 feet to better locate objects in the water. Mike Lane was operating the

Night Sun spotlight. The pilot, who was an instrument rated instructor, was flying IFR relying on his radar altimeter. As he made a sharp turn to the right, while trying to identify something in the water, the front skid made contact with the water. The helicopter plunged into the lake.

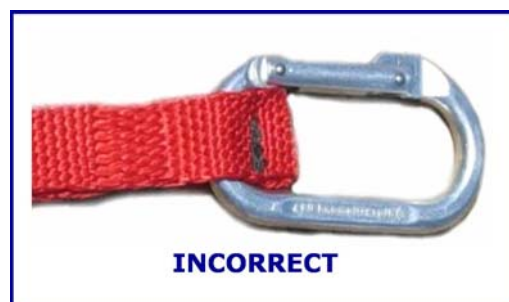
No. 04-05

During annual short-haul training, a check spotter observed an Omni-Sling™ brand webbing multi-loop strap being used incorrectly to connect a short-hauler to the main short-haul line.

The Omni-Sling multi-loop strap features an interwoven design which allows the user to safely attach a carabiner to multiple rigging loops along the length of the strap (see detailed blow-up for correct attachment of carabiner).

Do not attach a carabiner to the end of the strap (see detailed blow-up of incorrect attachment of carabiner). The sewn stitching at the end of the strap (used to attach a manufacturer's label) is not intended to be load bearing.

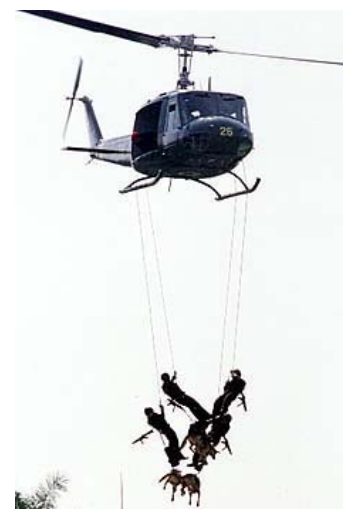
INDONESIA- SHORT HAUL ACCIDENT

On October 4, 2003 eight Indonesian Kopassus soldiers plunged 180 meters to their death, after being suspended below a military helicopter during a training exercise for a ceremony. Inhabitants of the coastal village of Lhokseumawe watched the accident, which occurred 300 meters offshore. According to Army spokesman, Col. Yani Basuki “A blast of wind rocked the Bell helicopter making it highly unstable”, and the crew “had no option but to cut the rope to which the men were attached.” Basuki said cutting the rope was “normal operating procedure” and done to save those on board the helicopter. No trace of the soldiers in full battle gear was ever found after they hit the water.

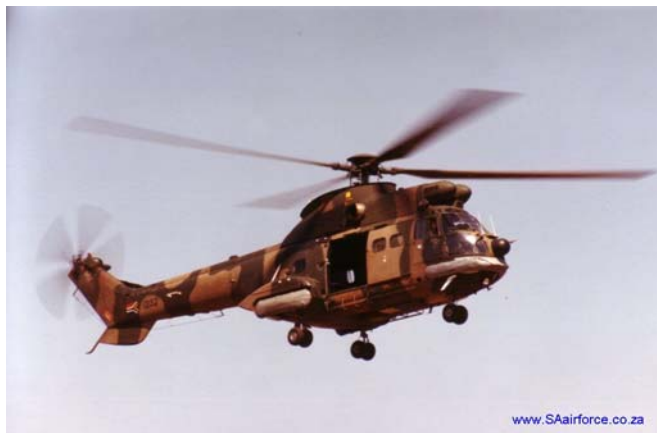
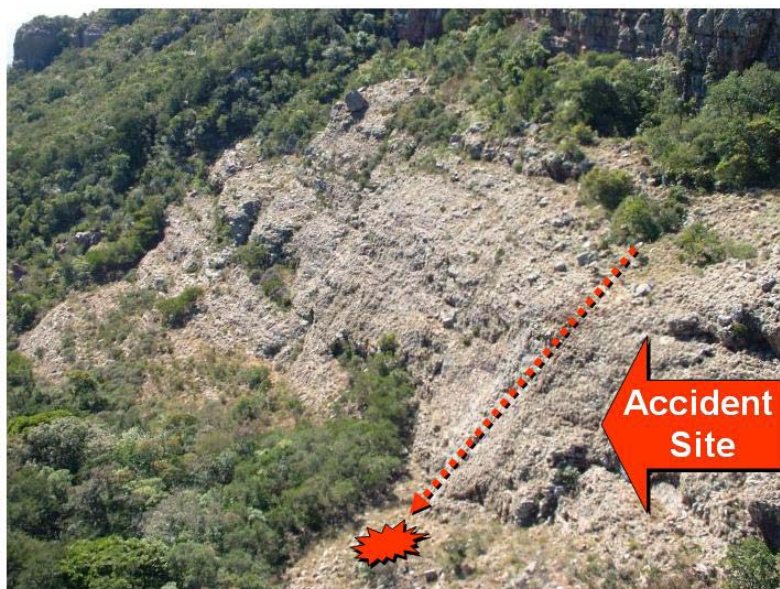
SOUTH AFRICA- HELICOPTER RESCUE TRAINING FATALITY

The accident occurred during a refresher training, when two teams were conducting hoisting evolutions and one-wheel loads/unloads. The helicopter involved was **Aerospatiale Oryx**, which is the local South African modified version of the SA 330 Puma and is fitted with wheeled tricycle landing gear. This was a South Africa Air Force aircraft piloted by a colonel and lieutenant.

Seven members of the team had boarded the aircraft. The eighth member (Carr) was placing his pack into the aircraft, when the aircraft wheel on the ground slipped, and the pilot pulled power lifting the aircraft into the air. Clive was placing his pack into the aircraft, his balance was forward at the time and he was caught off guard- he appeared to lunge at the aircraft. He momentarily grabbed the aircraft, pulling the pack out in the process before apparently

losing his grip and dropping back to the ground, tumbling about 15 meters down a very steep slope. Clive was declared dead at the scene....

- ❖ **Formalize introductory helicopter training.**
- ❖ **Development of a series of ratings of helicopter competence.**
- ❖ **Rescue Officer (RO) / Team Leader / Dispatcher has the discretionary rights to select an appropriate team for a job.** (*Dispatcher is a position on the ground SAR team like a loadmaster, who is a liaison to the helicopter crew chief*)

- ❖ **Formalize the Team Leader /Assistant Team Leader's training program.**
- ❖ **"Height-safety equipment", MUST have a standards rating for work at height.** (*e.g. No bicycle helmets, swift-water helmets, etc.*)

- ❖ **All carabiners used in helicopter work must be twist-lock.** (*To overcome aircraft vibration*)
- ❖ **Dog-handlers are excluded from one-wheel landing situations.** *MUST be hoisted.*

- ❖ **No excess equipment suspended from harness.** *This is due to the snag potential.*
- ❖ **Stretchered patients are not to be loaded in a one-wheel landing.** *They must be loaded by short hoisting evolution instead.*
